# Manhole Inspection Summary

Manhole # S53K\_\_065MH

Insp Date: **4/9/08 8:20 AM**

**Location** Address: **3101 Fait Av**

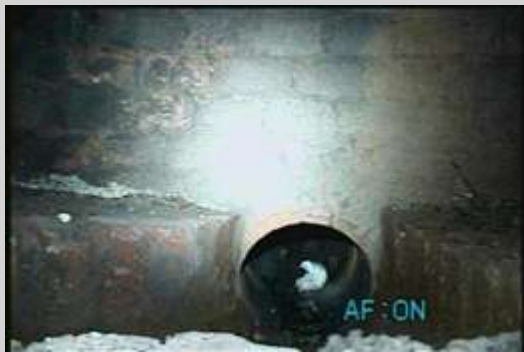
12 O'Clock Outflow

8 in. Circular Gravity Sewer  
Pipe Out @ 12 O'Clock

Pipe Material: **Clay** ☐ Pipe Lined

Invert Depth: **9.38** (ft.) Flow Characteristics: **Fast**

Infiltration: **None** Pipe Seal Cond: **Unknown**

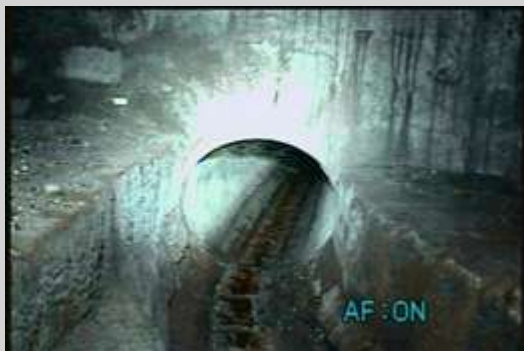
9 O'Clock Inflow

8 in. Circular Gravity Sewer  
Pipe In @ 9 O'Clock

Pipe Material: **Clay** ☐ Pipe Lined

Infiltration: **None** Pipe Seal Cond: **Unknown**
